FATAL FACTS

Report #5

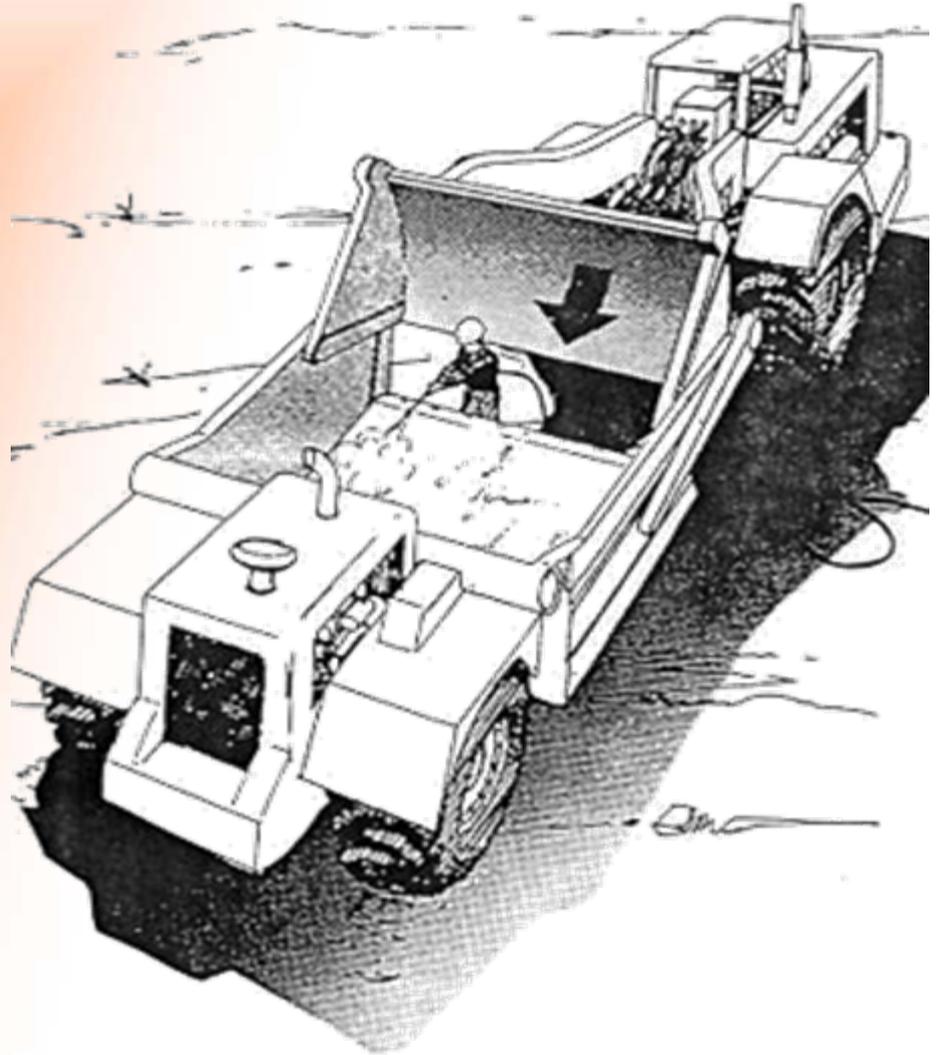
A laborer was steam cleaning a scraper. The bowl apron had been left in the raised position. The hydraulically controlled apron had not been blocked to prevent it from accidentally falling. The apron did fall unexpectedly and the employee was caught between the apron and the cutting edge of the scraper bowl. The apron weighted approximately 2500 pounds.

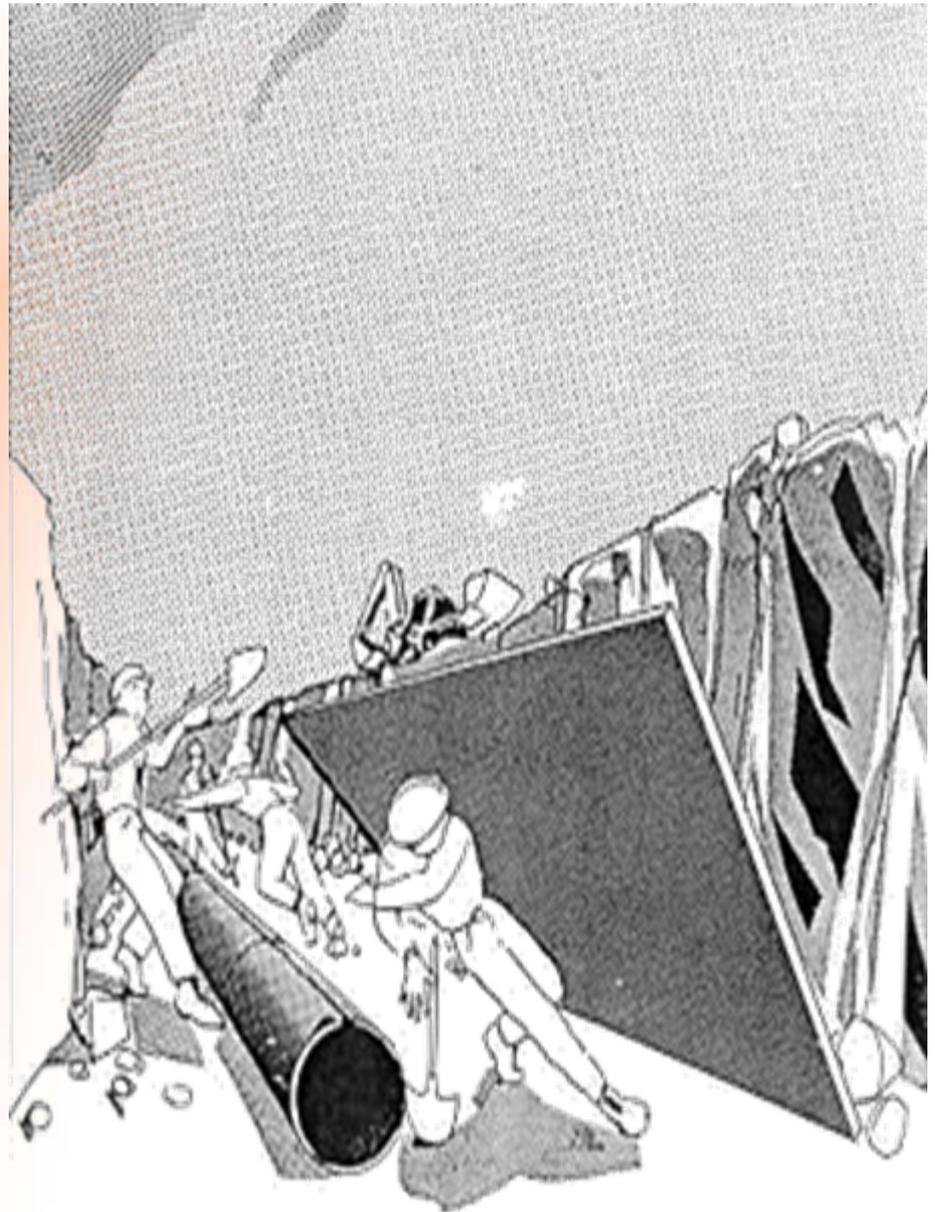
Report #13

Four employees were boring a hole and pushing a 20-inch pipe casing under a road. The employees were in an excavation approximately 9 feet wide, 32 feet long and 7 feet deep. ...

The steel plate on the south wall tipped over, pinning an employee (who was killed) between the steel plate and the pipe casing.

At the time the plate tipped over, a backhoe was being operated adjacent to the excavation.

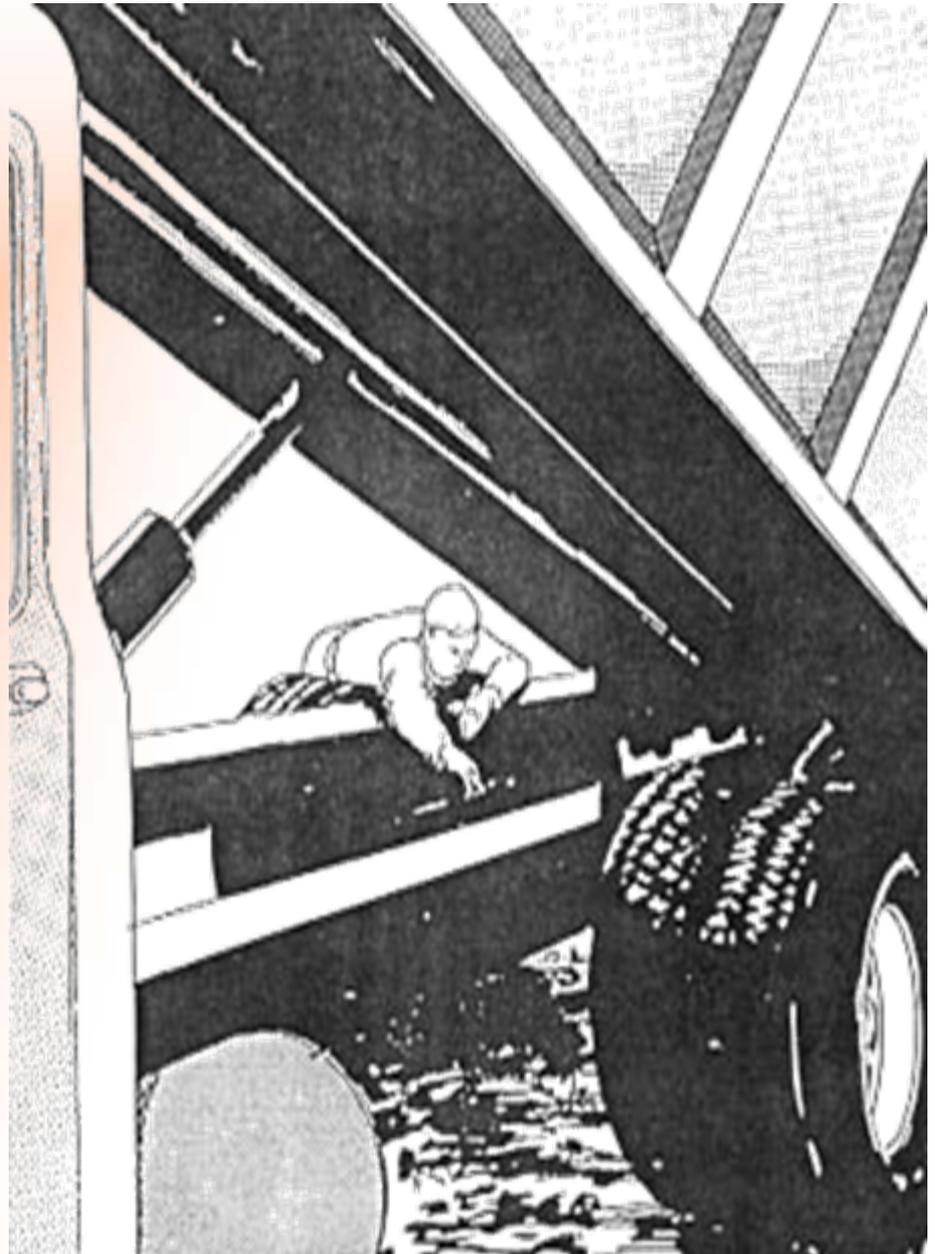
Report #15

A truck driver was crushed and killed between the frame and dump box of a dump truck.

The dump box then dropped suddenly, crushing his head.

The employee had not received training or instruction in proper operating procedures and was not made aware of all potential hazards in his work.

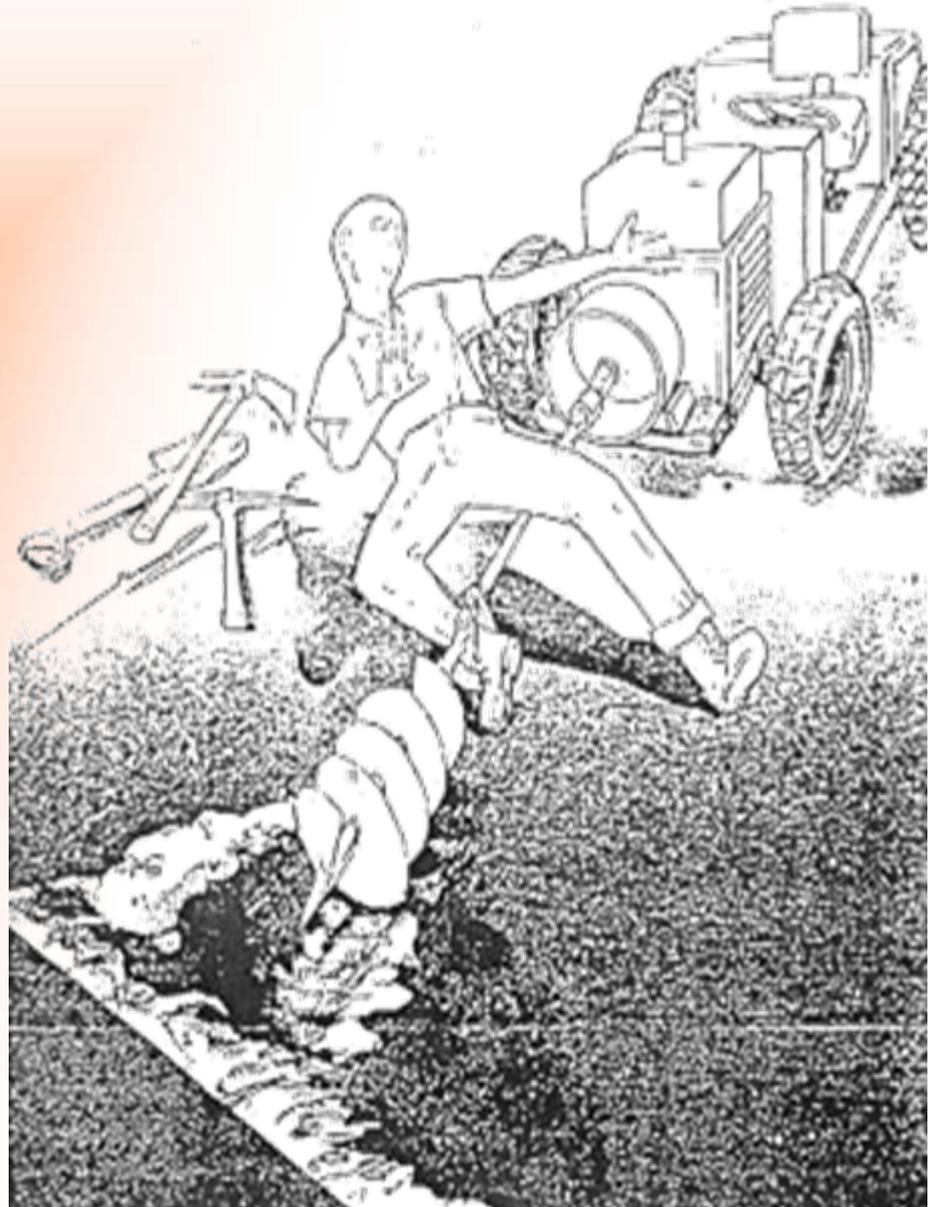
Report #18

A three-man crew was installing an underground telephone cable in a residential area. They had just completed a bore hole under a driveway using a horizontal boring machine. The bore hole rod had been removed from the hole. While the rod was still rotating, the operator straddled it and stooped over to pick it up. His trouser leg became entangled in the rotating rod and he was flipped over. He struck tools and materials, sustaining fatal injuries.

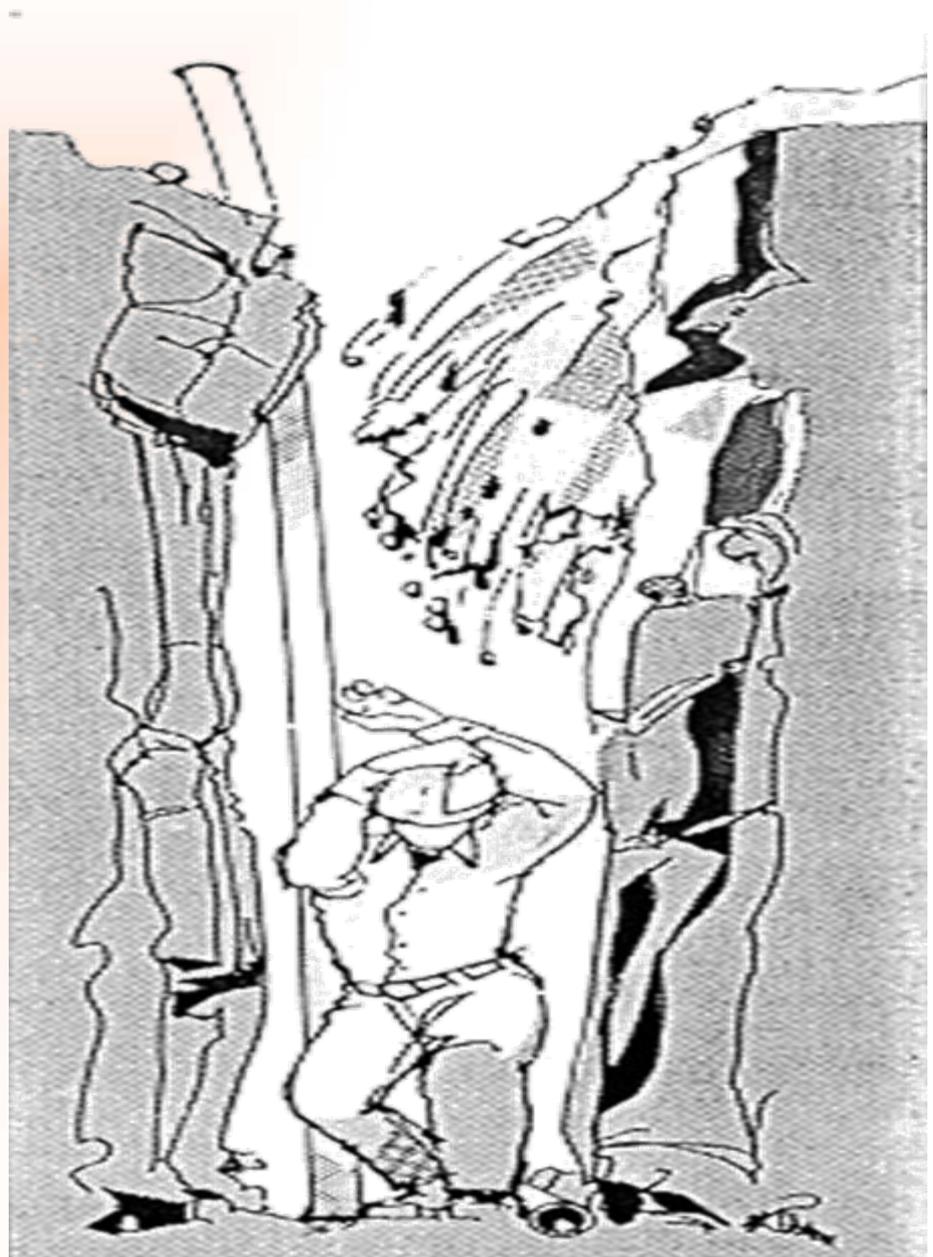
Report #22

An employee was installing a small diameter pipe in a trench 3 feet wide, 12-15 feet deep and 90 feet long. The trench was not shored or sloped nor was there a box or shield to protect the employee. Further, there was evidence of a previous cave-in. The employee apparently reentered the trench, and a second cave-in occurred, burying him. He was found face down in the bottom of the trench.

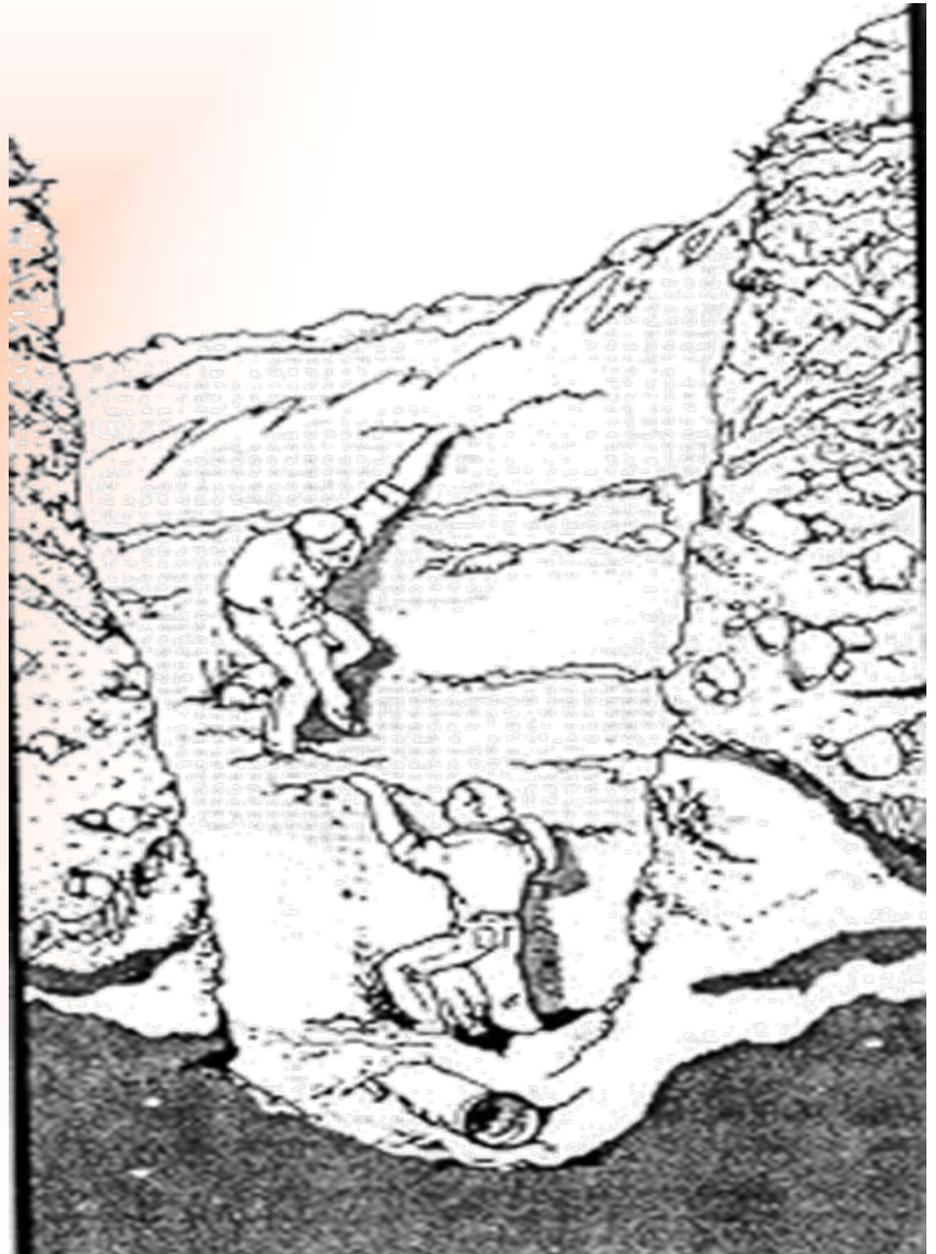
Report #31

Employees were laying sewer pipe in a trench 15 feet deep. The sides of the trench, 4 feet wide at the bottom and 15 feet wide at the top, were not shored or protected to prevent a cave-in. ... [see report]...

As they attempted to leave the trench, there was a small cave-in covering one employee to his ankles. When the other employee went to his co-worker's aid another cave-in occurred covering him to his waist. ... [see report]...

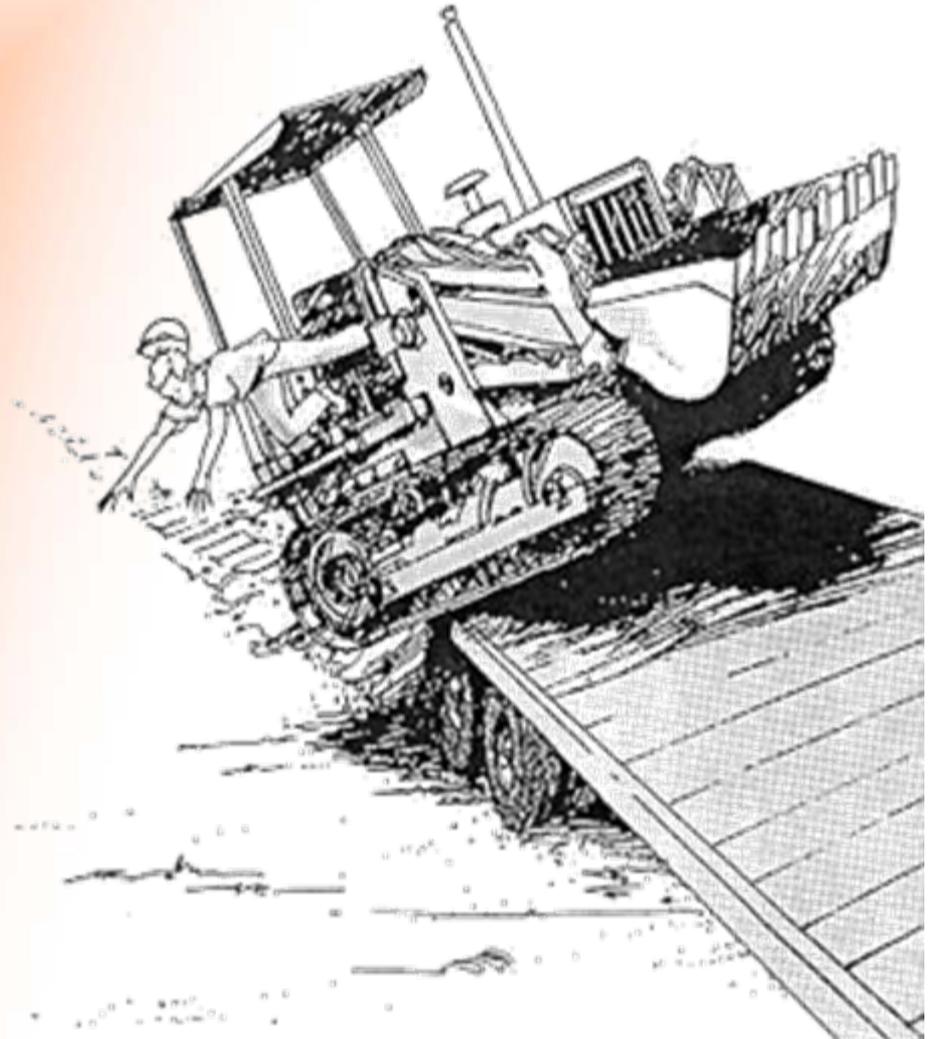
Report #38

An employee was driving a front-end loader up a dirt ramp onto a lowboy trailer. The tractor tread began to slide off the trailer. As the tractor began to tip, the operator, who was not wearing a seat belt, jumped from the cab. As he hit the ground, the tractor's rollover protective structure fell on top of him, crushing him.

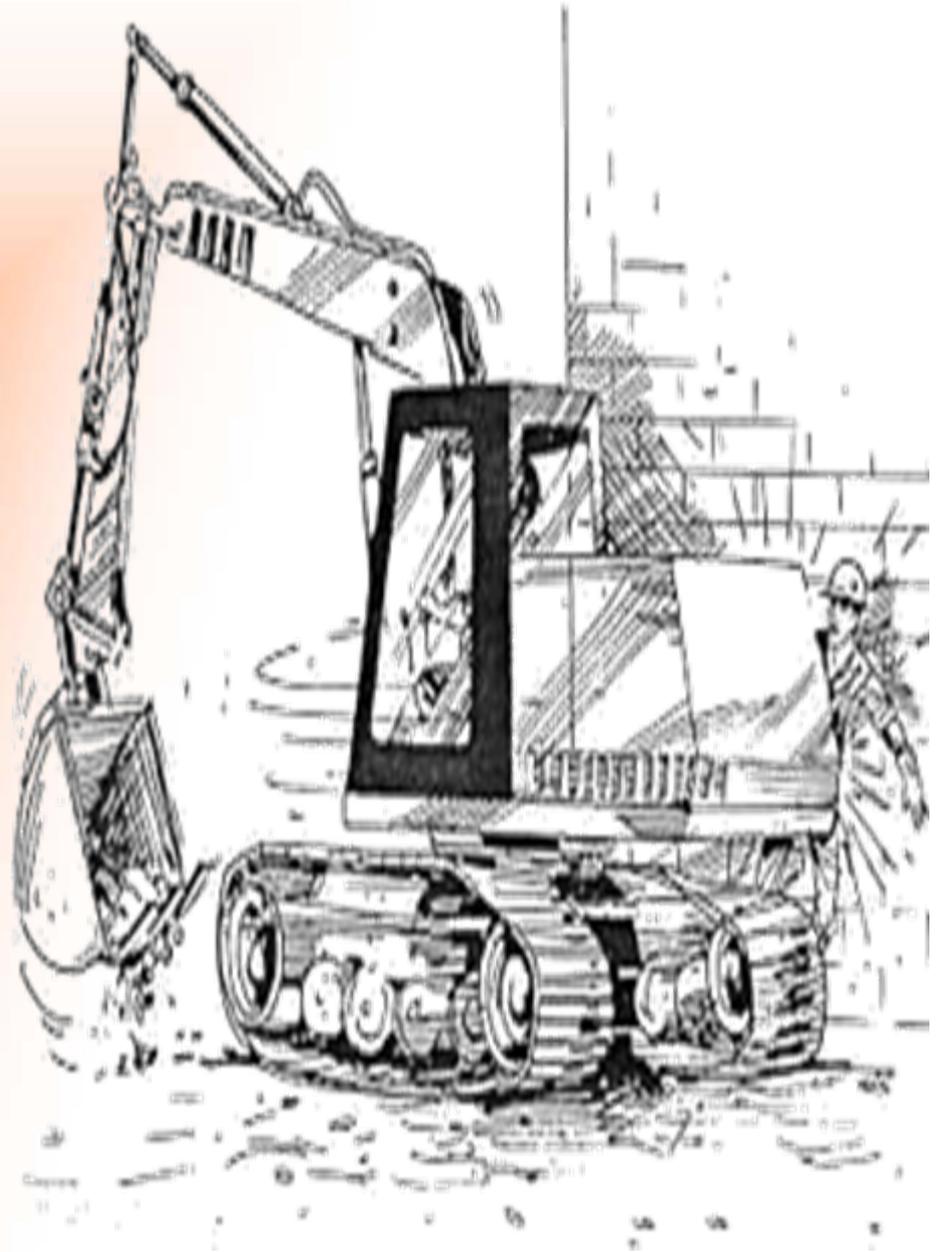
Report #50

The contractor was operating a backhoe when an employee attempted to walk between the swinging superstructure of the backhoe and a concrete wall. As the employee approached the backhoe from the operator's blind side, the superstructure hit the victim crushing him against the wall.

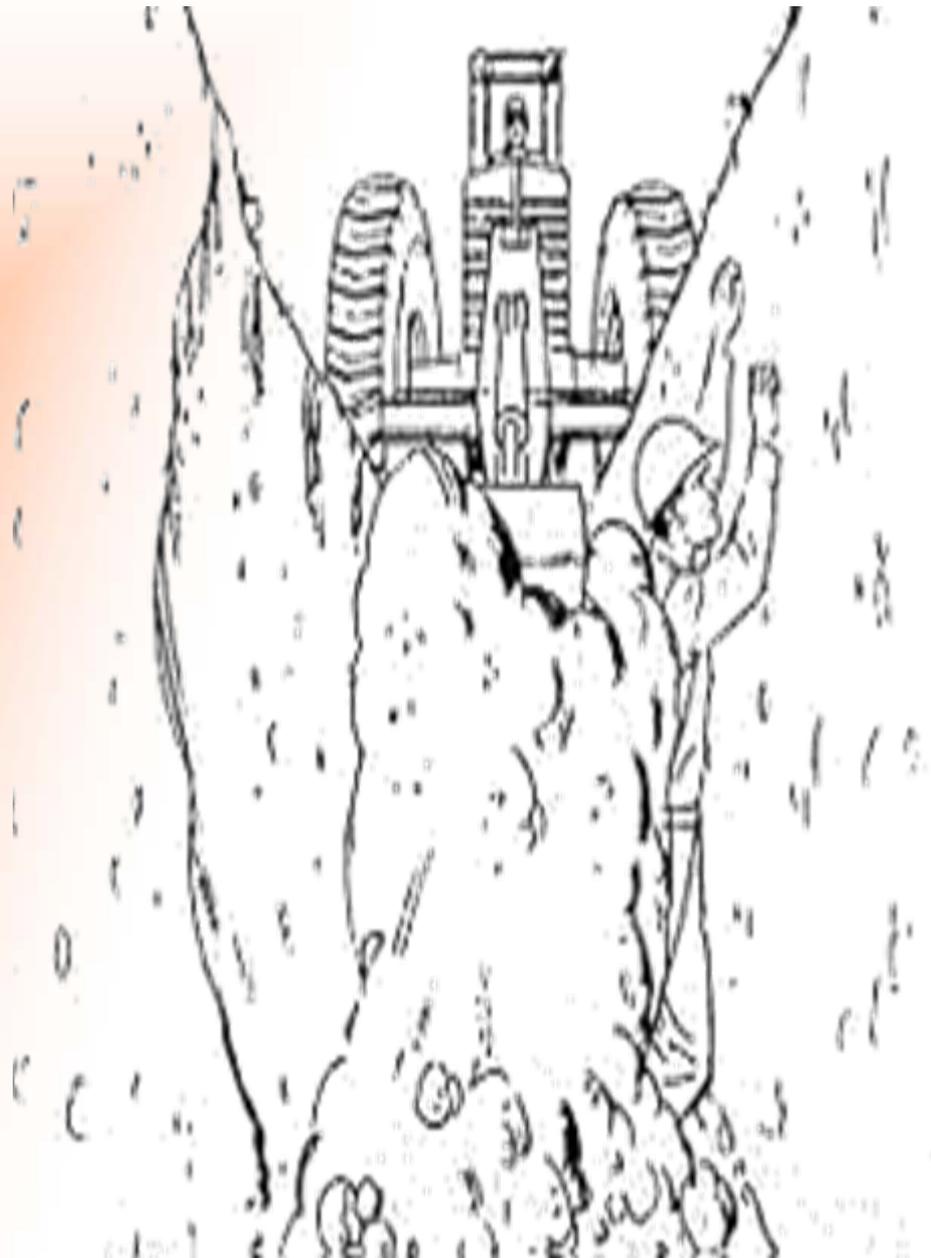
Report #61

An employee was working in a trench 4 feet wide and 7 feet deep. About 30 feet away a backhoe was straddling the trench when the backhoe operator noticed a large chunk of dirt falling from the side wall behind the worker in the trench, he called out a warning. Before the worker could climb out, 6 to 8 feet of the trench wall had collapsed on him and covered his body up to his neck. He suffocated before the backhoe operator could dig him out. ...[see report]...

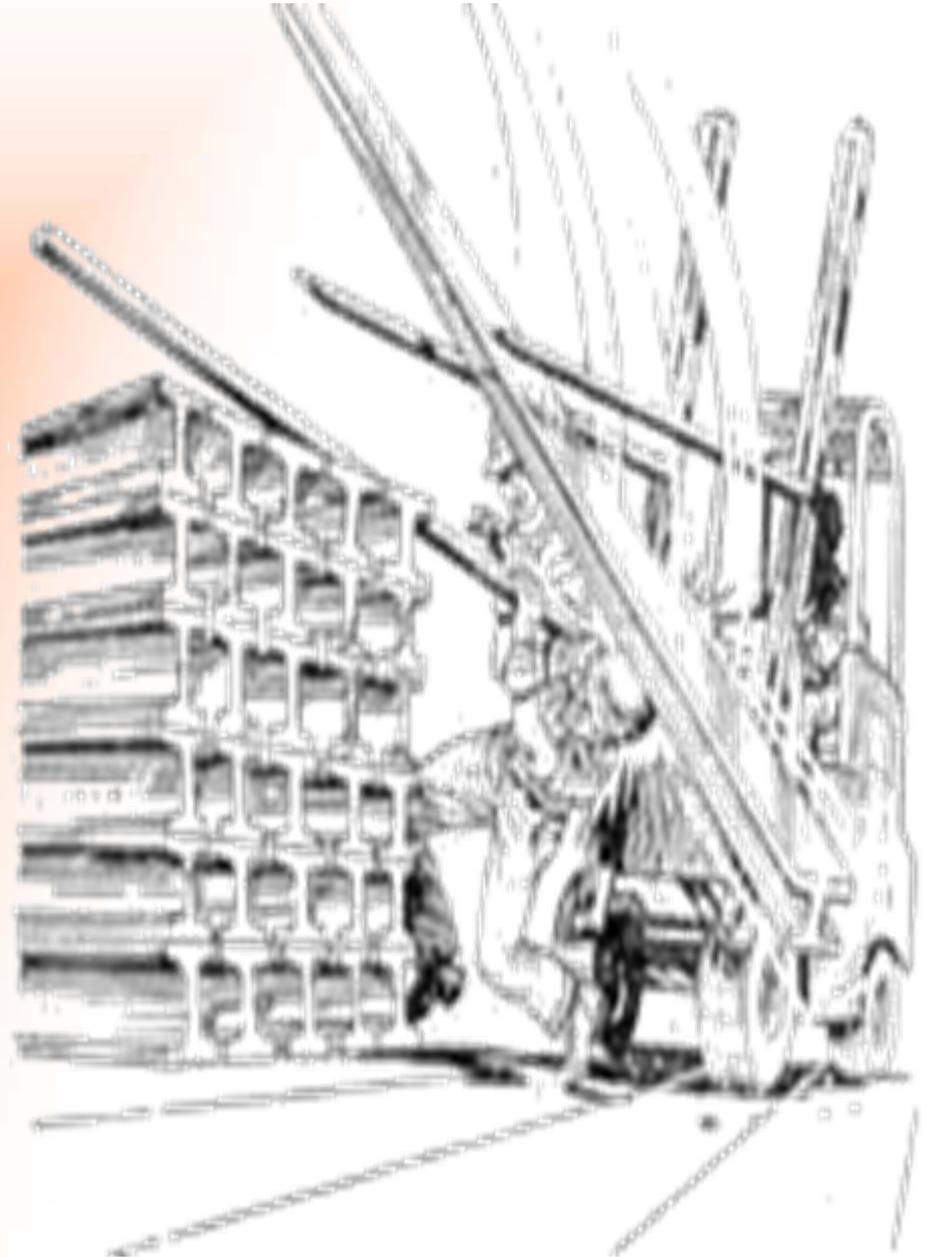
Report #73

Two laborers and a fork lift driver were staking 40-foot-long I-beams in preparation for structural steel erection. One laborer was placing a 2 X 4 inch wooden spacer on the last I-beam on the stack. The fork lift driver drove up to the stack with another I-beam that was not secured or blocked on the fork lift tines. The I-beam fell from the tines, pinning the laborer between the fallen I beam and the stack of beams.
