The PV Installation Process

Sales, Site Assessment and Estimation

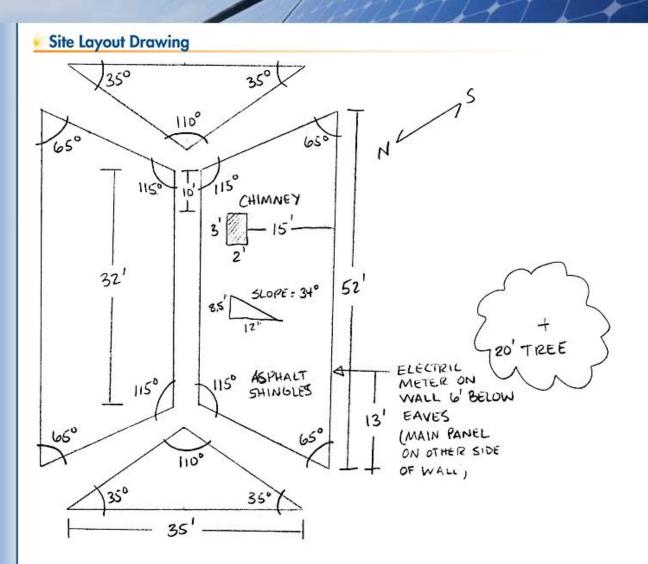
A site layout drawing shows basic building dimensions and locations of major components.

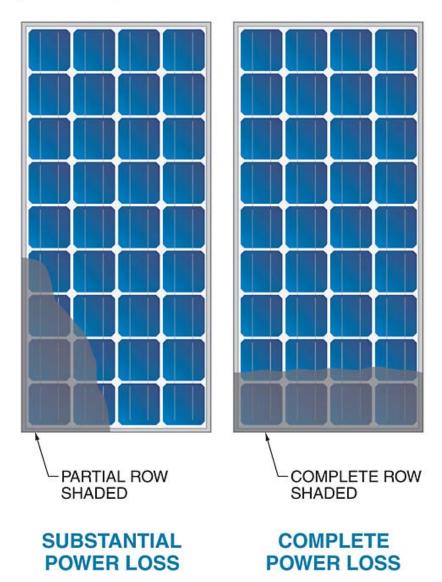
Shading of PV modules and arrays can cause disproportional reductions in power output.

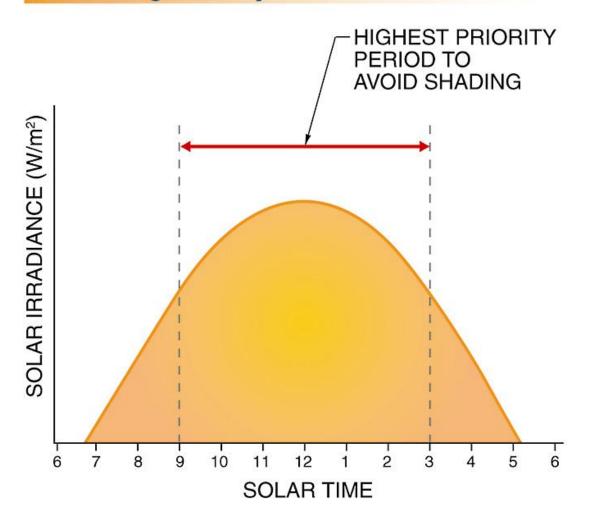
Shading Priority

Most of the daily solar radiation occurs between 9 AM and 3 PM, so avoiding shading during this period is high priority.

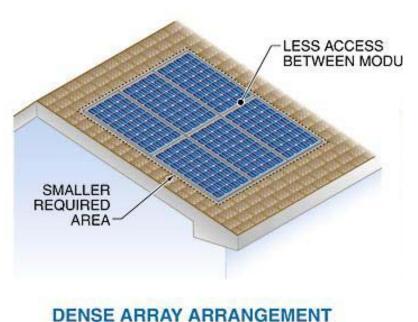
Array Area Requirements

- Length x width = Area
- Area x 15W = apprx power availability
- Only an approximation
- Not a substitute for PV sizing!
- Does not adjust for orientation, tilt, shade, etc

Overall output is based on solar resource, shading, module efficiency, etc. but there is a good site survey rule of thumb: 15W per square foot of available area
